RADC-TR-77-410
Final Technical Report
December 1977

RELIABILITY STUDY OF DOPED ALUMINUM CONDUCTOR FILMS

Motorola Semiconductor Products Group

ROME AIR DEVELOPMENT CENTER
Air Force Systems Command
Griffis Air Force Base, New York 13441

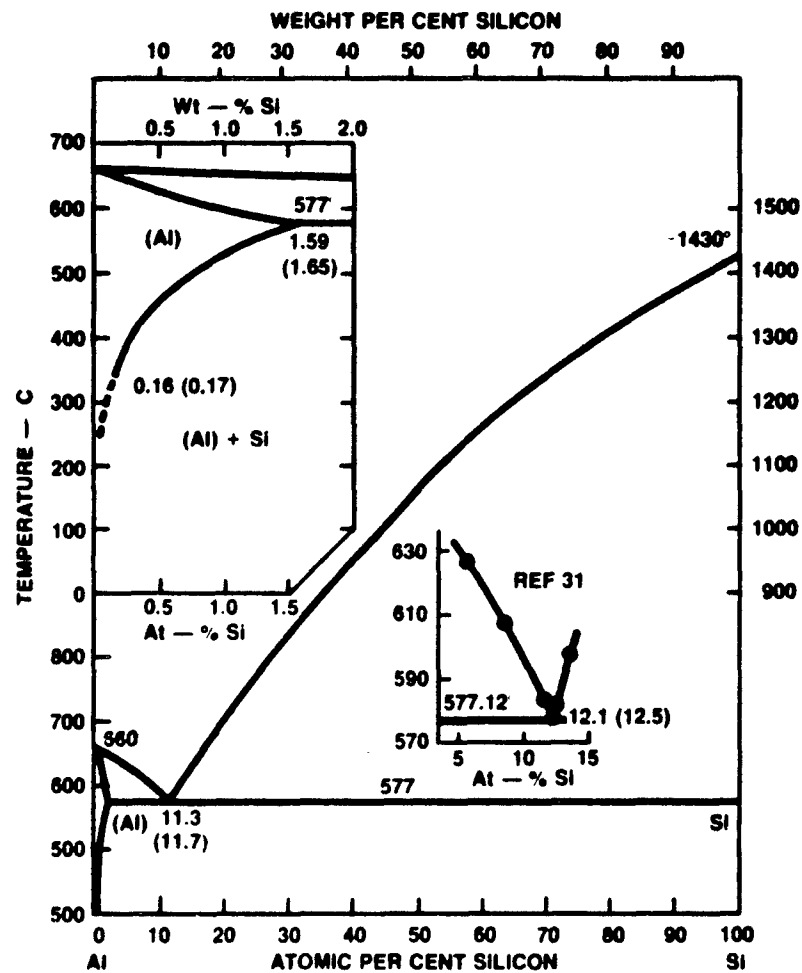
FIGURE 1. ALUMINUM-SILICON PHASE DIAGRAM

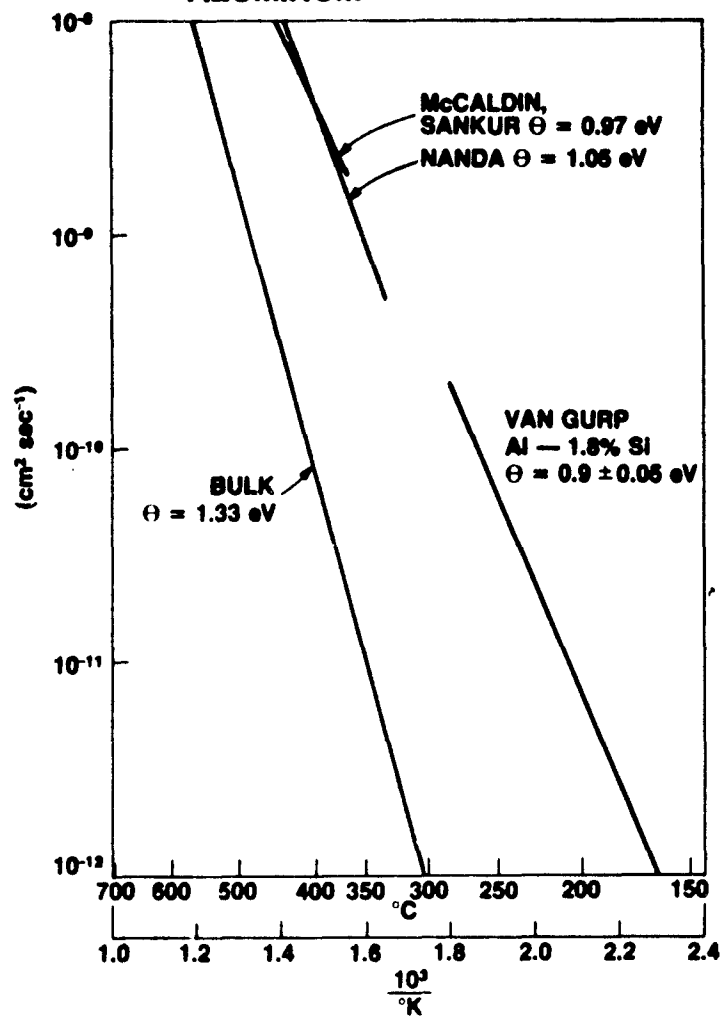
FIGURE 2. THE DIFFUSIVITY OF SILICON IN SOLID ALUMINUM

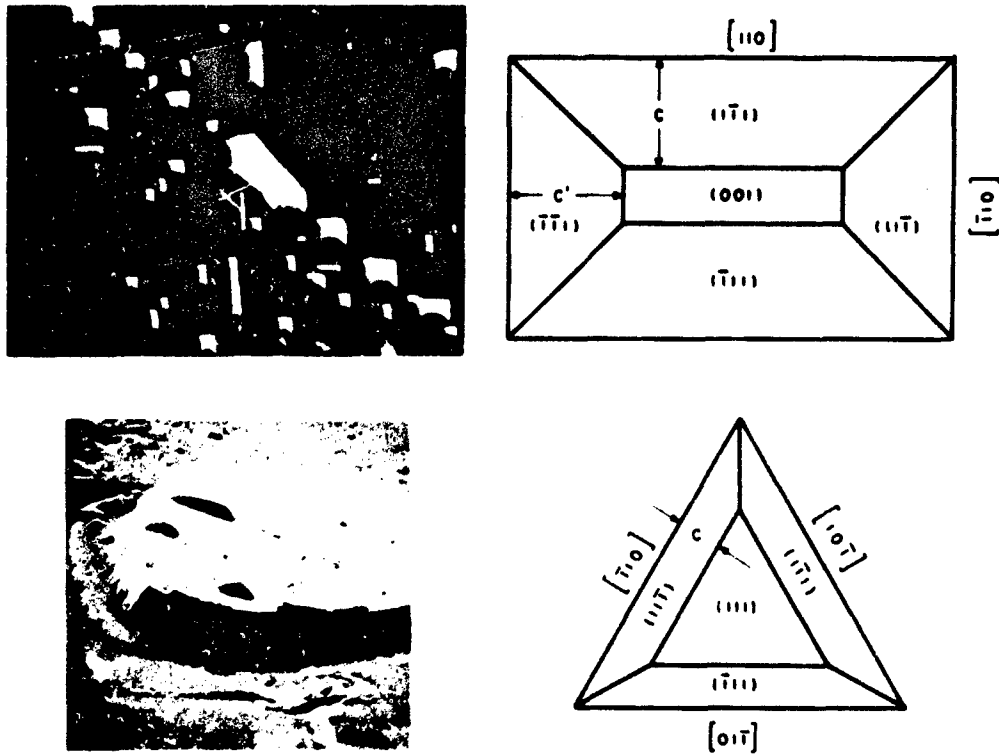
FIGURE 3. THE MORPHOLOGY OF SILICON DISSOLUTION PITS. THE SEM PHOTOGRAPHS ON THE LEFT ARE REPLICAS OF Al-Si CONTACTS AFTER REMOVAL OF THE Al. THE DRAWING INDICATES THE CRYSTALLOGRAPHIC SHAPE OF THESE PITS IN (100) AND (111) ORIENTED SILICON.

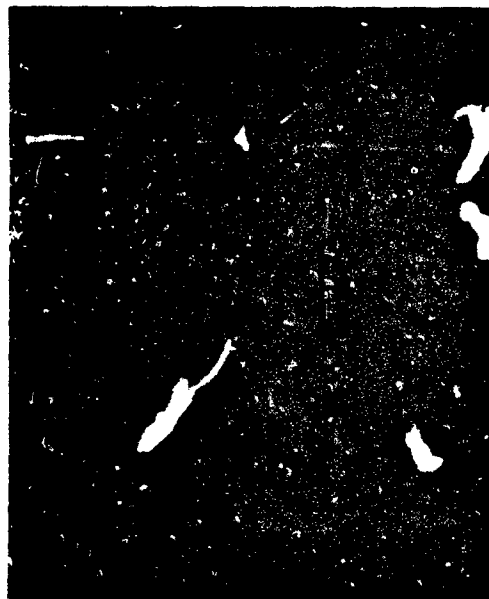
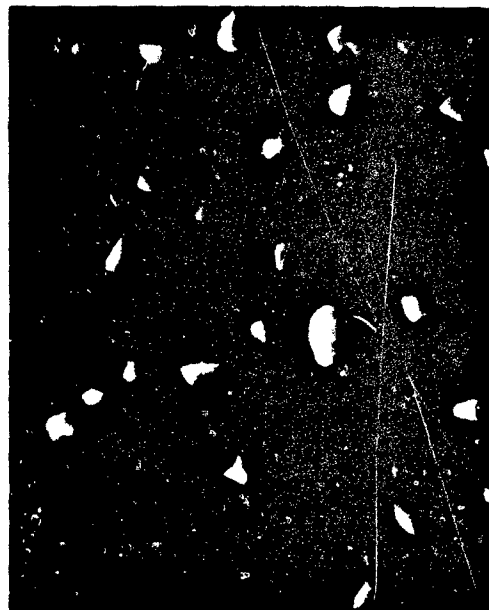
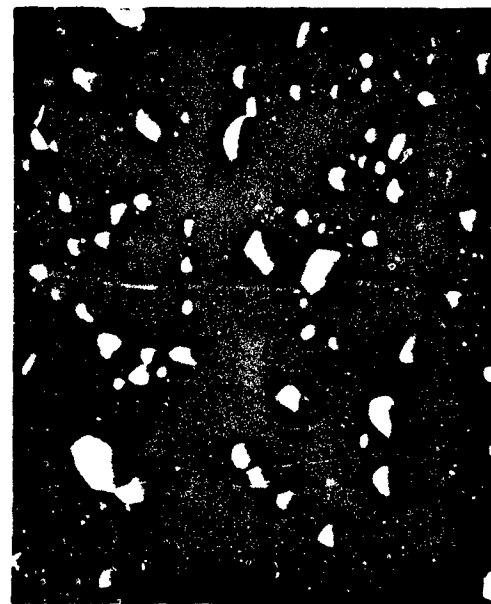
FIGURE 10. Al/Si ALLOY FILMS AFTER 15 MIN. AT 500°C FOLLOWED BY A FAST COOL AND Al ETCH. 5000X

When the films were heated to 500°C for a period of 15 minutes and subjected to a fast cool by quickly removing them from the furnace into air coarsening of the silicon was observed as shown in Figure 10 which are SEM micrographs taken at a magnification of 5000 X. The 0.79% Si alloy had elongated particles ($2.8 \mu\text{m}$ long) growing along grain boundaries and at tripple points with a particle density of 1.2×10^6 per cm^2 . The 1.9% Si alloy formed more spherical particles with a density of 8.4×10^6 per cm^2 and a maximum size of $2 \mu\text{m}$. The 3.0% Si alloy grew similar shaped and sized particles as did the 1.9% Si alloy however the particle density increased to 1.9×10^7 per cm^2 .

When these alloy films were heated to 500°C for 15 minutes, cooled at a fast rate by quickly pulling them out of the furnace into room temperature air, and then heated at 300°C for 161 hours and cooled quickly it was found that the extended anneal at 300°C caused very little change in the Si distribution and structure. Figure 12 shows the Si formed in the quenched and annealed films. These appear similar to Figure 10 which shows the silicon structure of the quenched, but unannealed films.

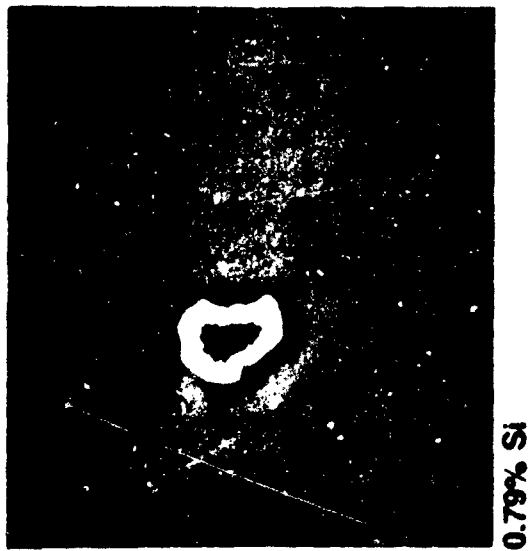
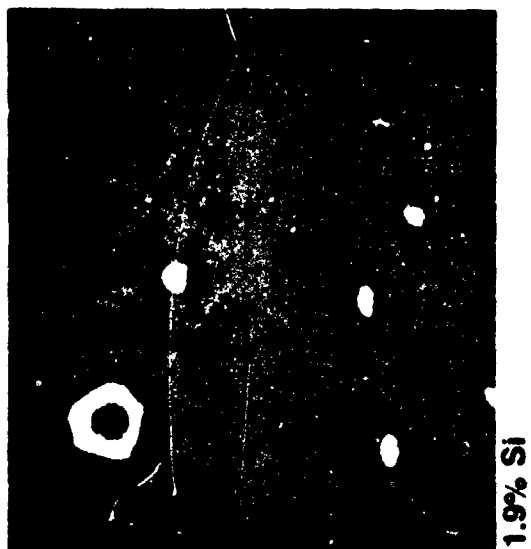
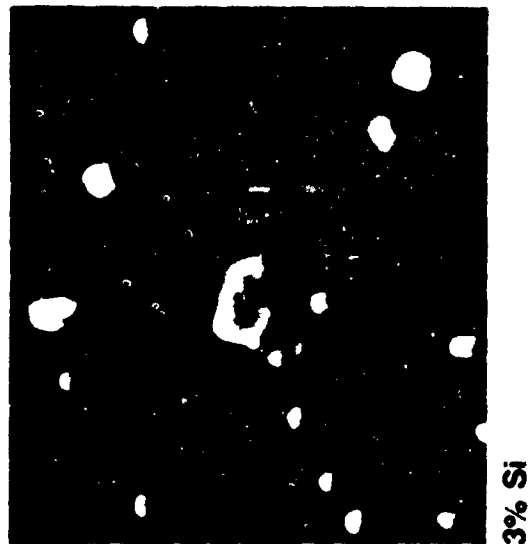
FIGURE 11. Al/Si ALLOY FILMS AFTER 15 MIN. AT 500°C FOLLOWED BY SLOW COOLING AND Al ETCH. 5000X

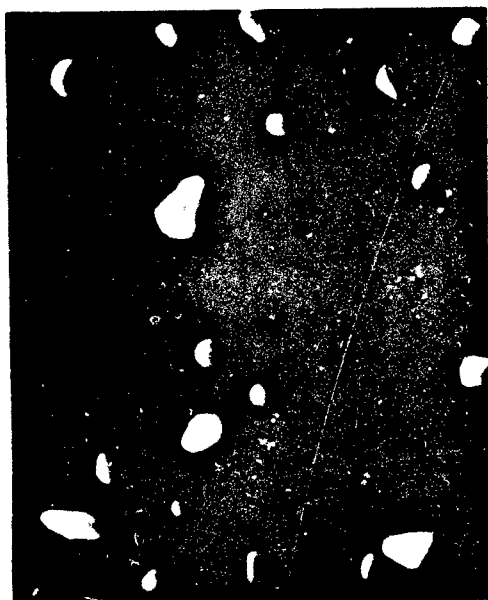
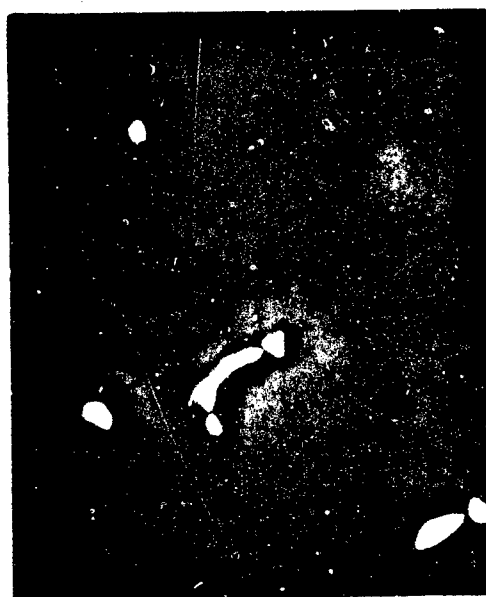
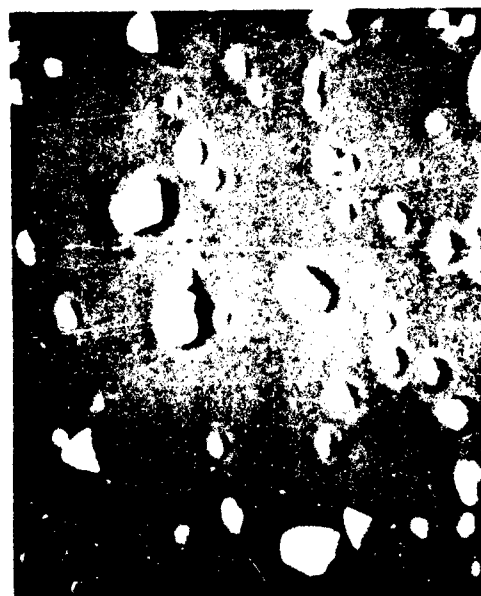
FIGURE 12. Al/Si ALLOY FILMS AFTER 15 MIN. AT 500°C, FAST COOL, 161 HOURS AT 300°C FOLLOWED BY FAST COOLING AND Al ETCH. 5000X

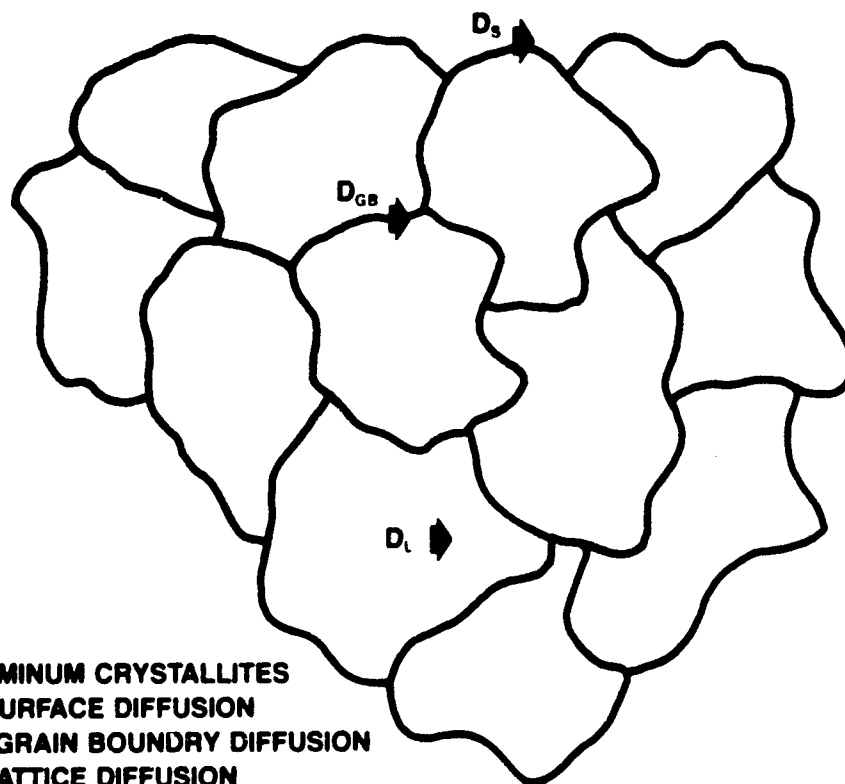
ALUMINUM CRYSTALLITES
 D_s SURFACE DIFFUSION
 D_{GB} GRAIN BOUNDARY DIFFUSION
 D_l LATTICE DIFFUSION

FIGURE 13. THREE POSSIBLE LOCATIONS WHERE ELECTROMIGRATION CAN OCCUR IN POLYCRYSTALLINE ALUMINUM.

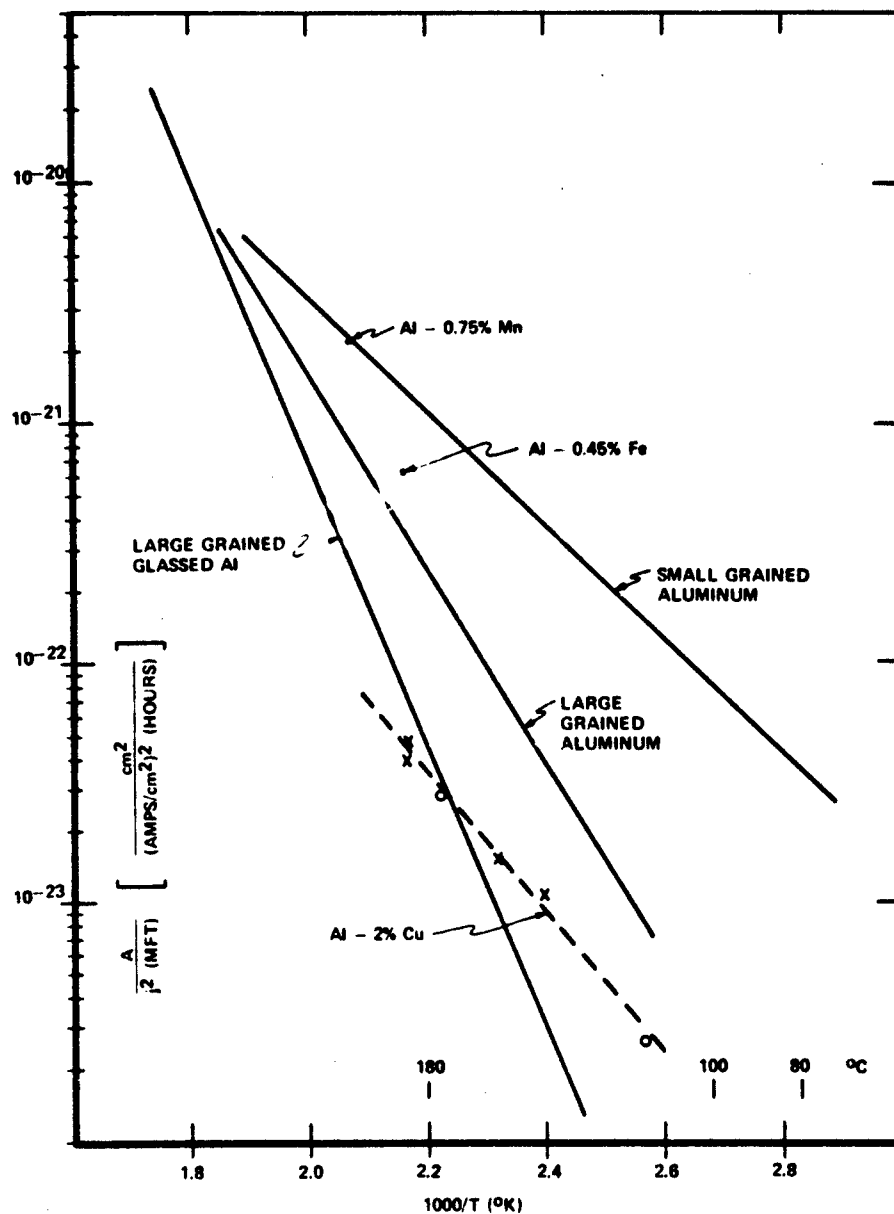
FIGURE 14. MEDIAN TIME TO FAILURE OF SOME ALUMINUM ALLOYS AS A FUNCTION OF CURRENT DENSITY j , TEMPERATURE T , AND CROSS-SECTION AREA A .

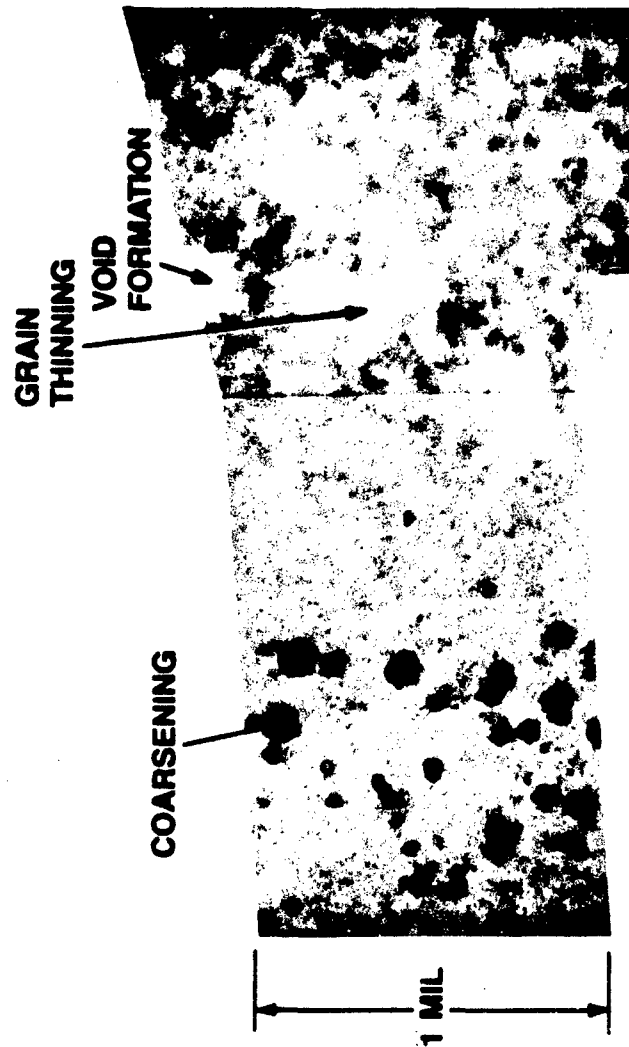
FIGURE 16. AN ELECTRON BEAM INCLUDED CURRENT (EBIC) MODE PHOTOGRAPH OF A ONE MIL WIDE AL-2% CU STRIPE DURING AN ELECTROMIGRATION EXPERIMENT.

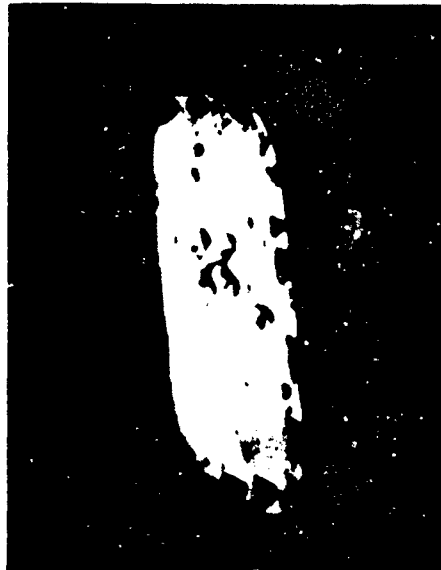
FIGURE 17. ETCH PITS FORMED BY
ELECTROMIGRATION
OF Si THROUGH Al
(NEGATIVE TERMINAL).

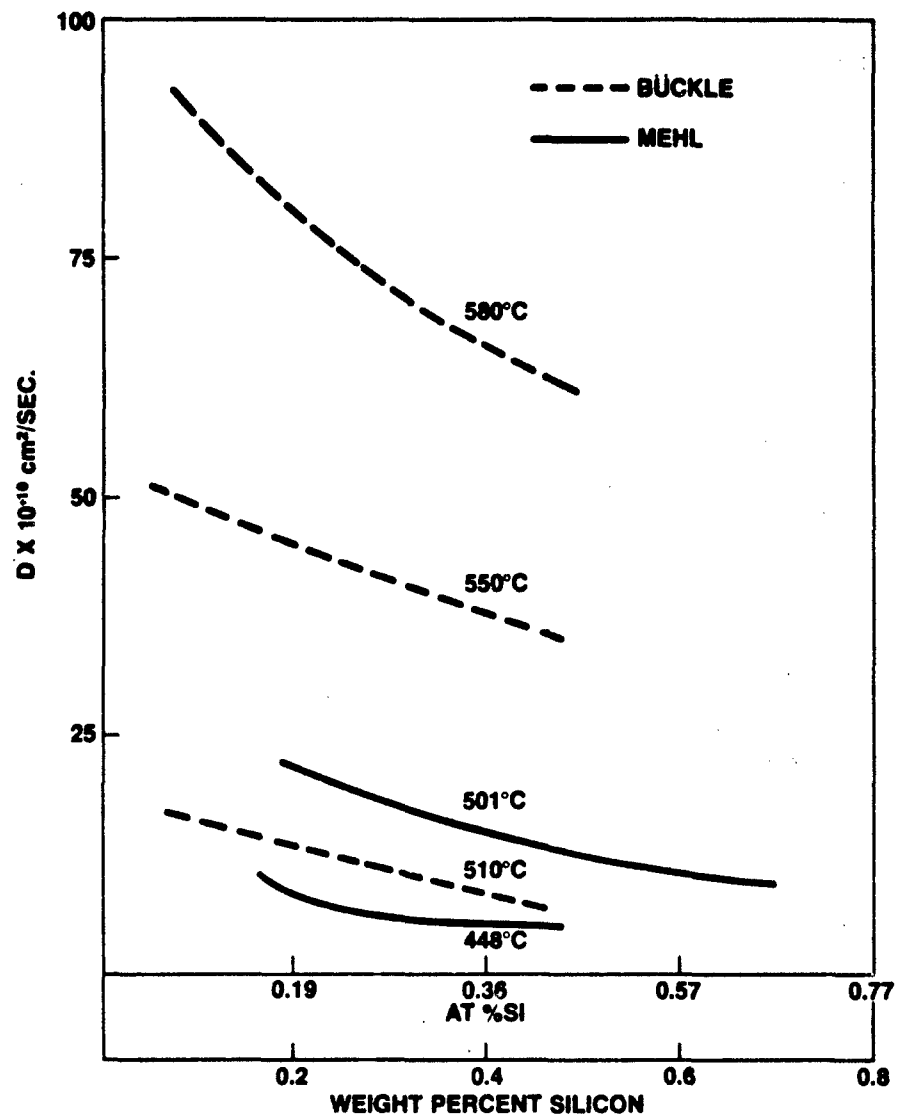
FIGURE 19. CHEMICAL DIFFUSION IN BULK Al-Si ALLOYS

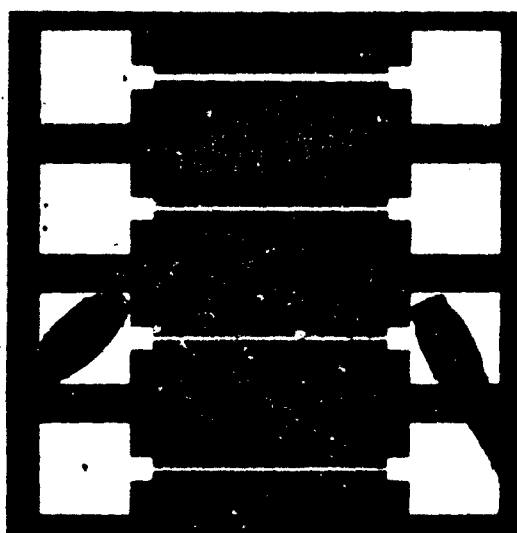
**FIGURE 20. LOW TEMPERATURE
ELECTROMIGRATION
TEST DIE.**

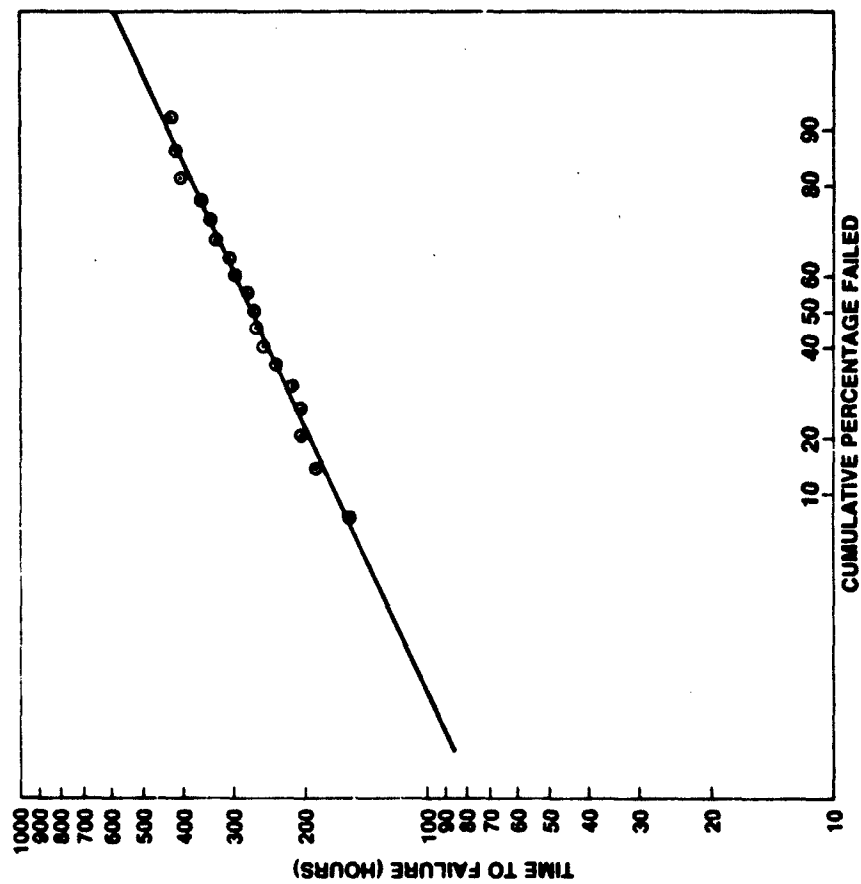
**FIGURE 21. LOG NORMAL PLOT OF A 19 DEVICE CELL
STRESSED AT 167°C AT $J = 8 \times 10^5$ A/cm²**

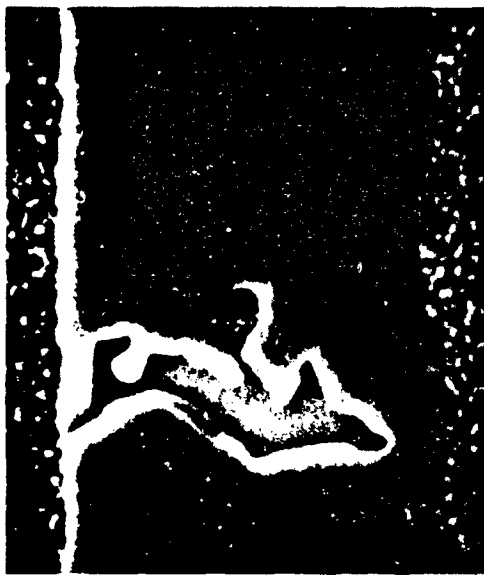
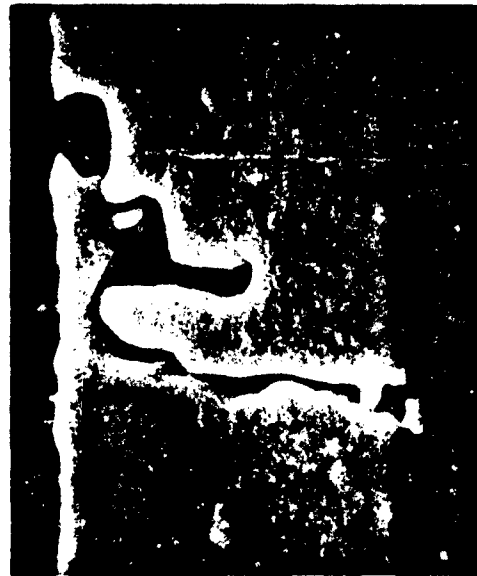
**FIGURE 22. VOIDS FORMED IN Al/Si ALLOYS DURING ELECTROMIGRATION TEST
AT LOW TEMPERATURES. 5000X**

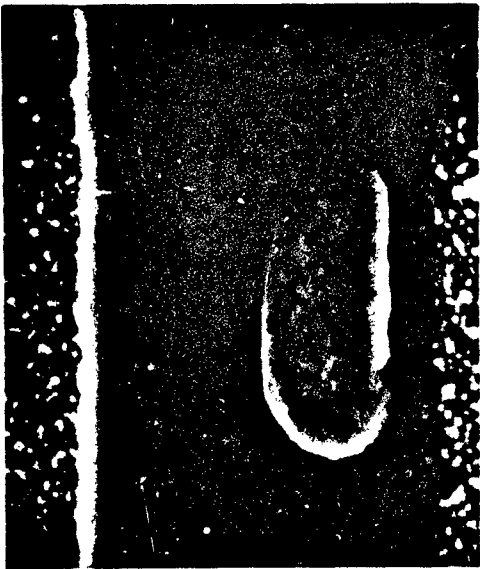
FIGURE 23. CRACKED PASSIVATION GLASS DUE TO HILLOCK GROWTH BEFORE
AND AFTER GLASS REMOVAL. 6000X

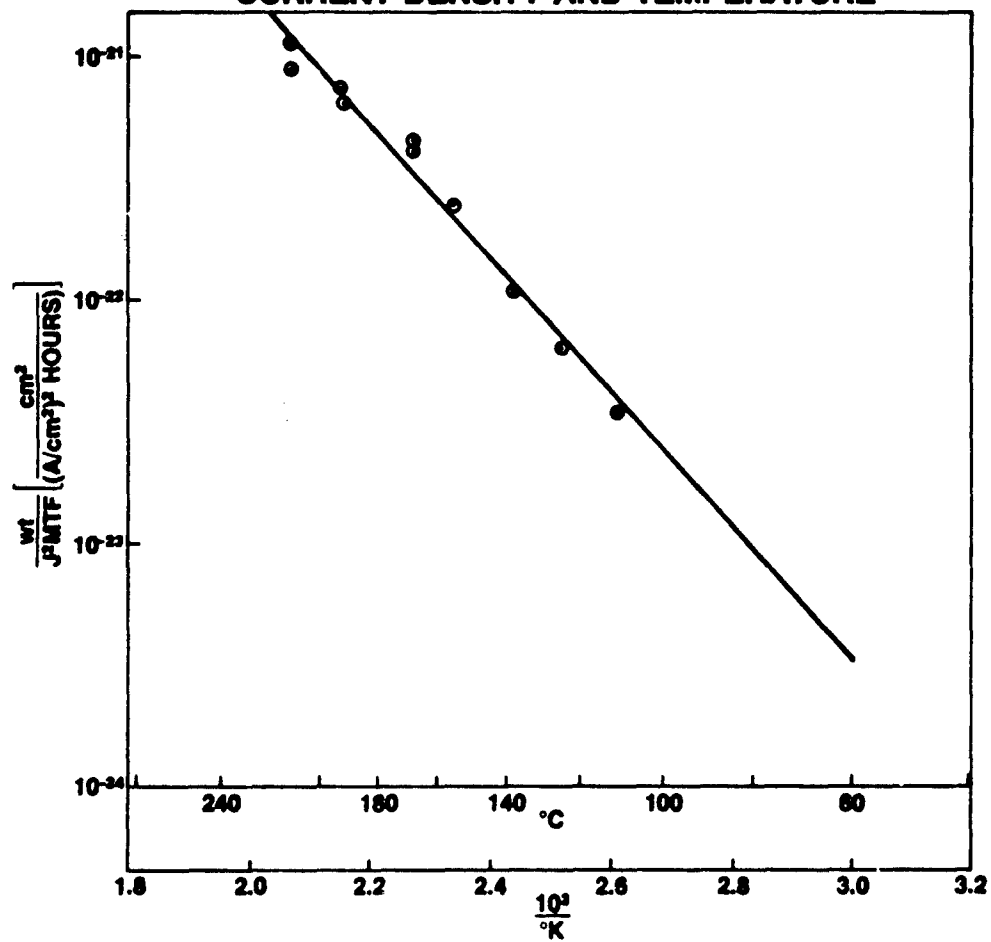
**FIGURE 25. Al — 1.9% Si ALLOY DATA RELATING MEDIAN
TIME TO FAILURE TO FILM GEOMETRY,
CURRENT DENSITY AND TEMPERATURE**

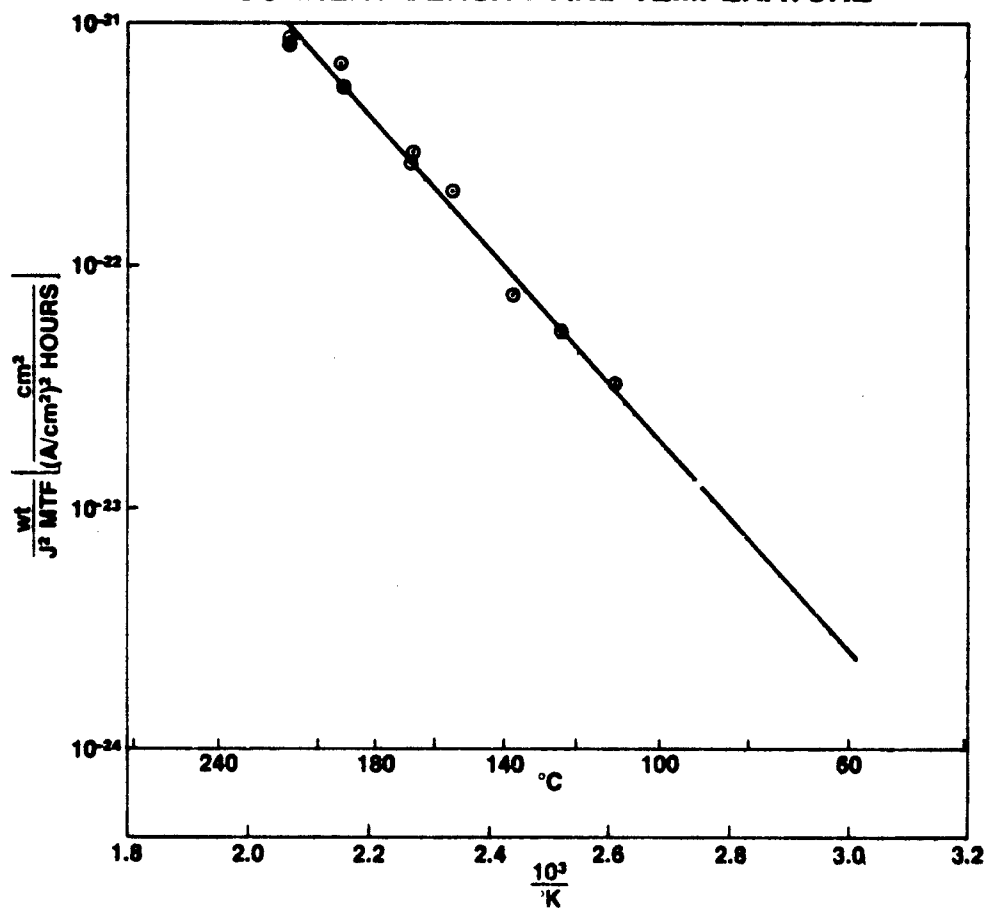
**FIGURE 26. Al — 3.0% SI ALLOY DATA RELATING MEDIAN
TIME TO FAILURE TO FILM GEOMETRY,
CURRENT DENSITY AND TEMPERATURE**

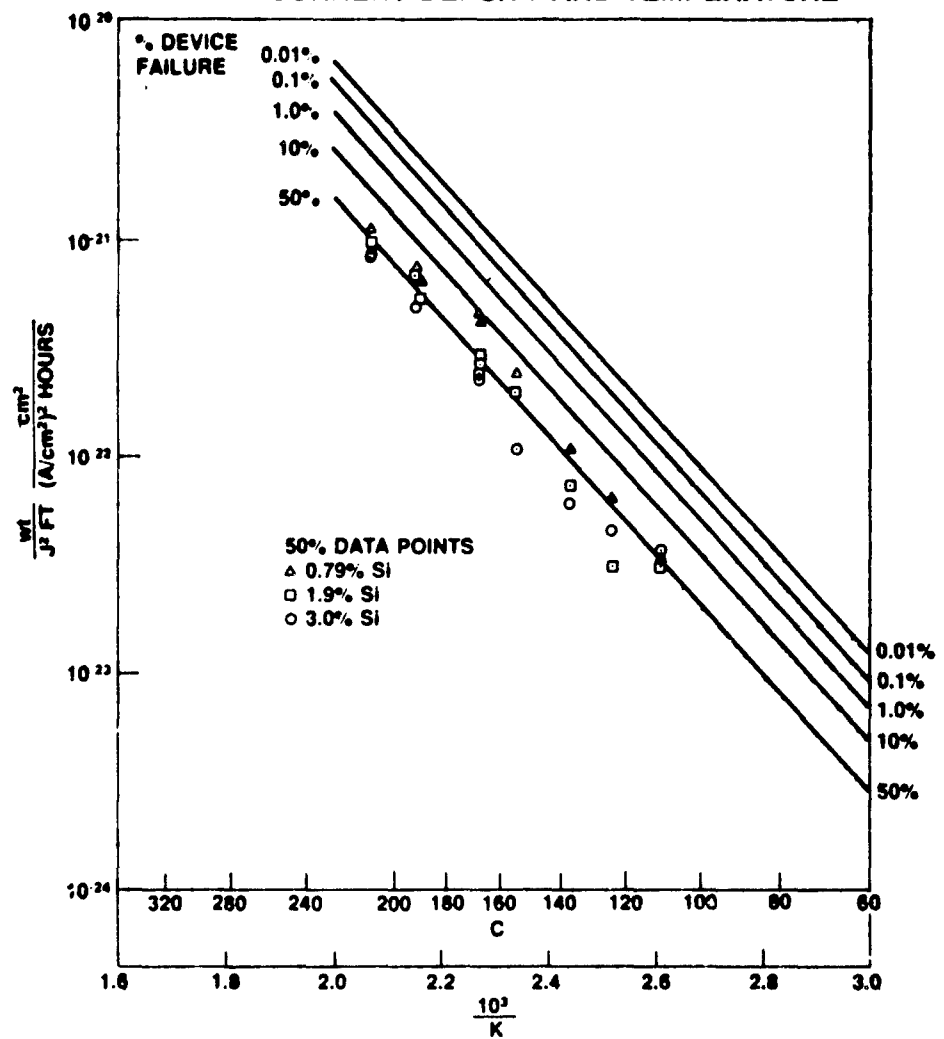
FIGURE 27. COMBINED Al/Si ALLOY DATA RELATING %
DEVICE FAILURE TIME TO FILM GEOMETRY,
CURRENT DENSITY AND TEMPERATURE

It is of interest to note that the lifetime of the passivated alloy films are 2-3 times greater than pure small grained aluminum that was not passivated. (Compare Figure 27 with Figure 14). This can be attributed to the passivation glass which restricts hillock growth causing the metal to

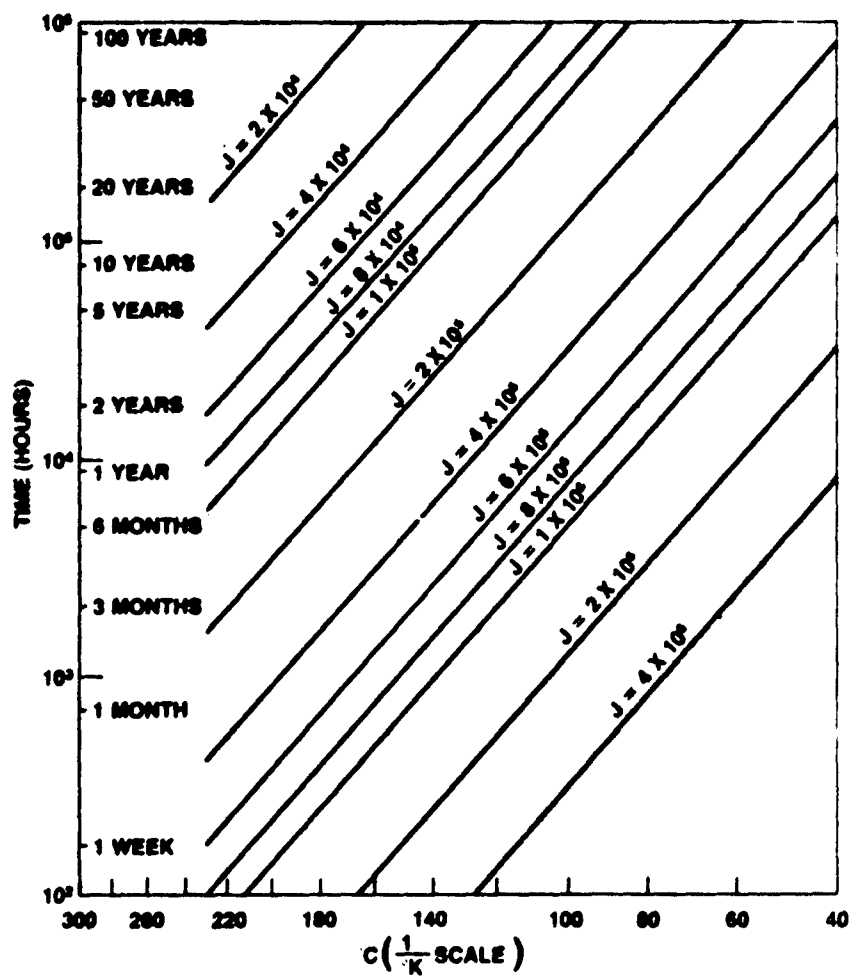
**FIGURE 28. 50% FAILURE TIME OF Al/Si ALLOY FILMS WITH
10⁻⁷ cm² CROSS-SECTIONAL AREA**

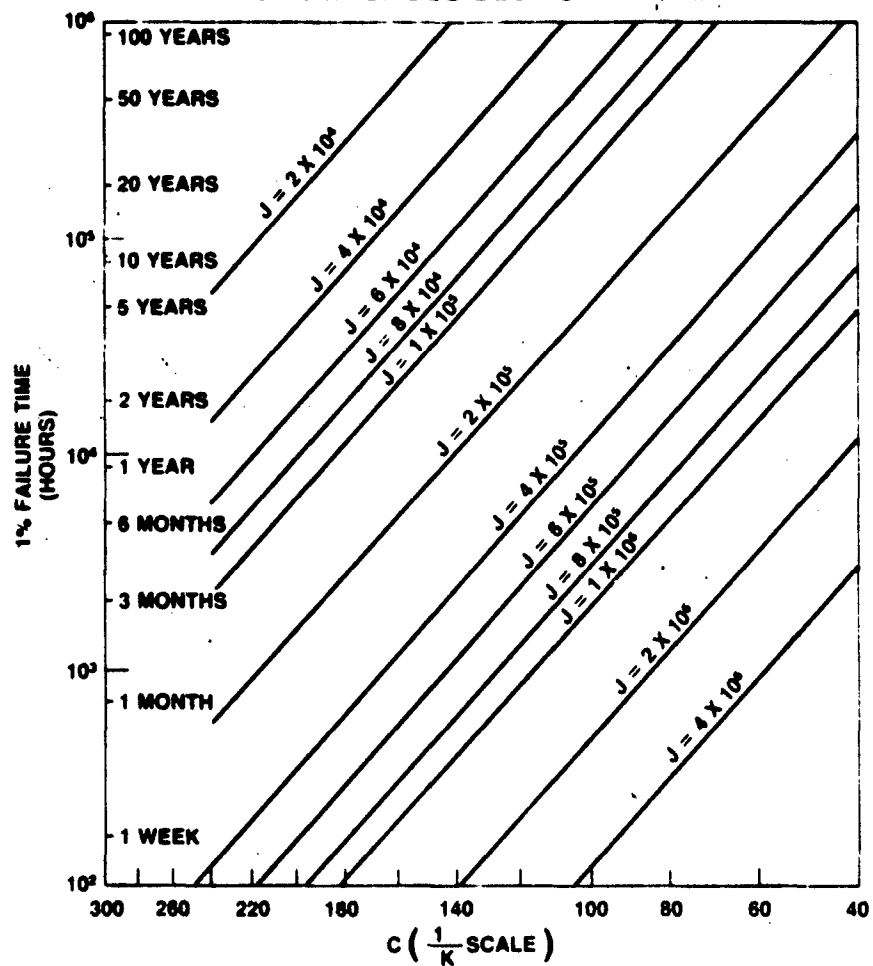
FIGURE 29. 1.0% FAILURE TIME OF Al/Si ALLOY FILMS WITH 10^{-7} cm² CROSS-SECTIONAL AREA

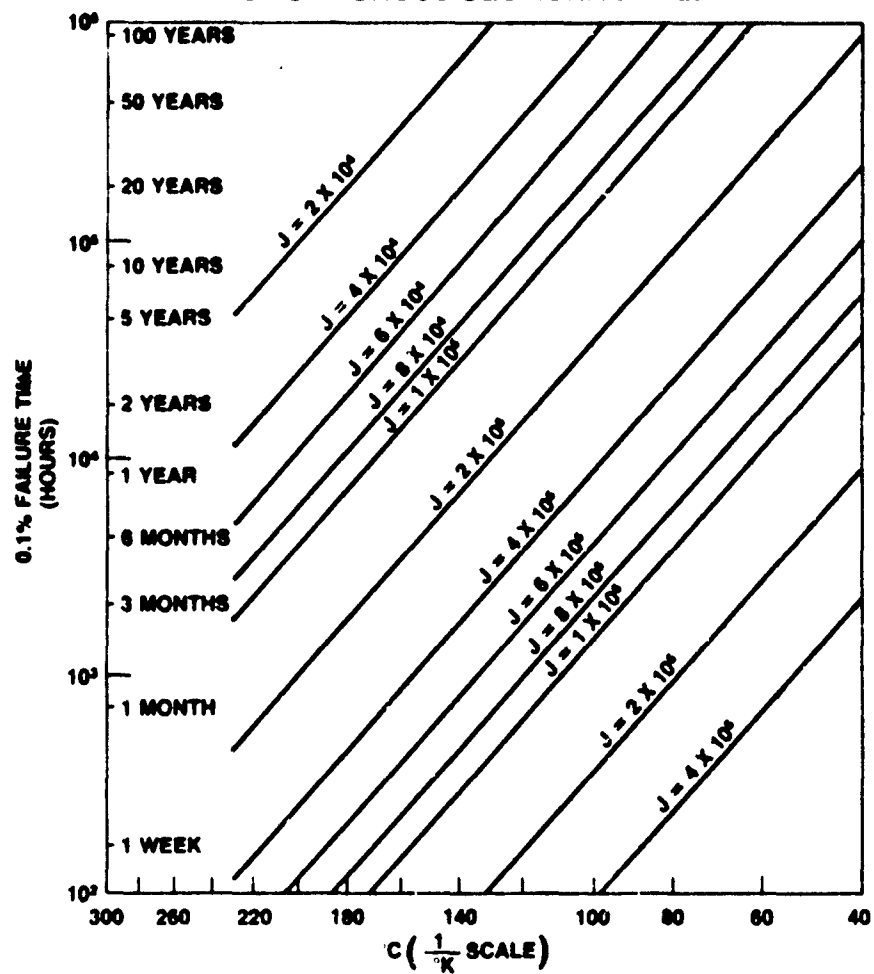
**FIGURE 30. 0.1% FAILURE TIME OF Al/Si ALLOY FILMS WITH
10⁻⁷ cm² CROSS-SECTIONAL AREA**

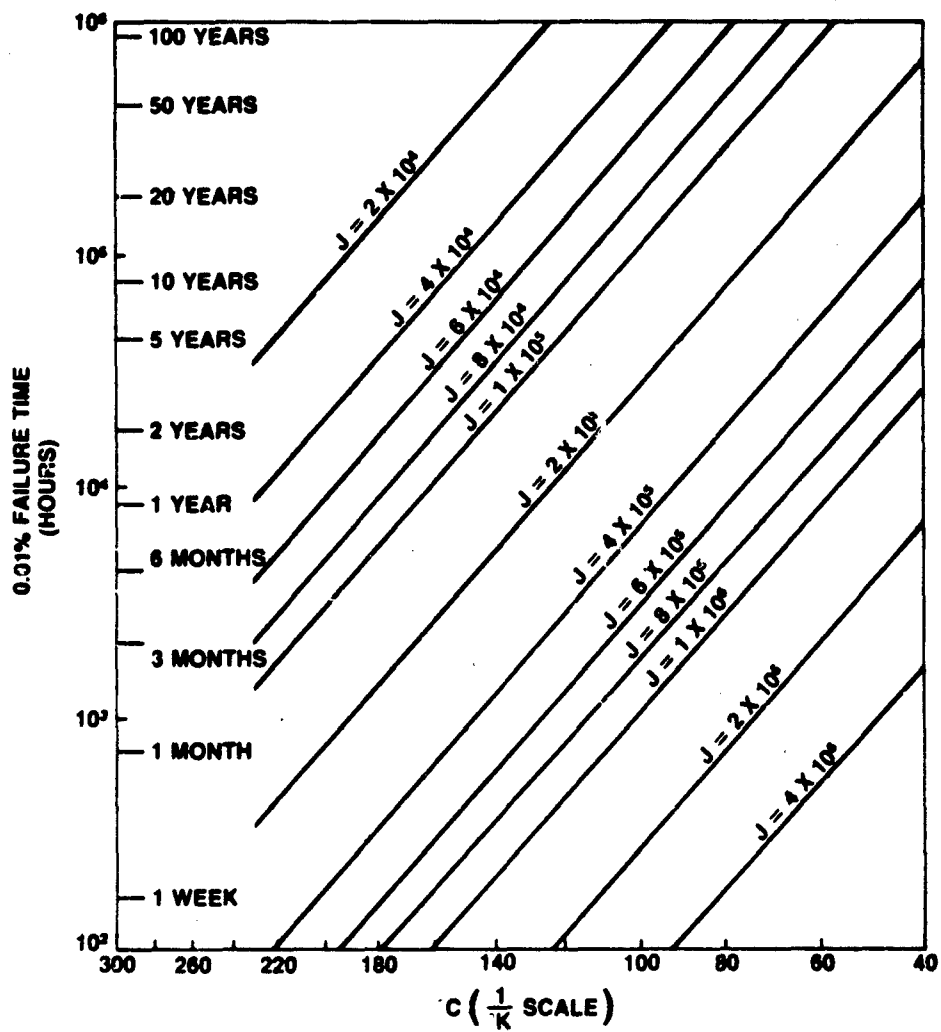
**FIGURE 31. 0.01% FAILURE TIME OF Al/Si ALLOY FILMS
WITH 10^{-7} cm² CROSS-SECTIONAL AREA**

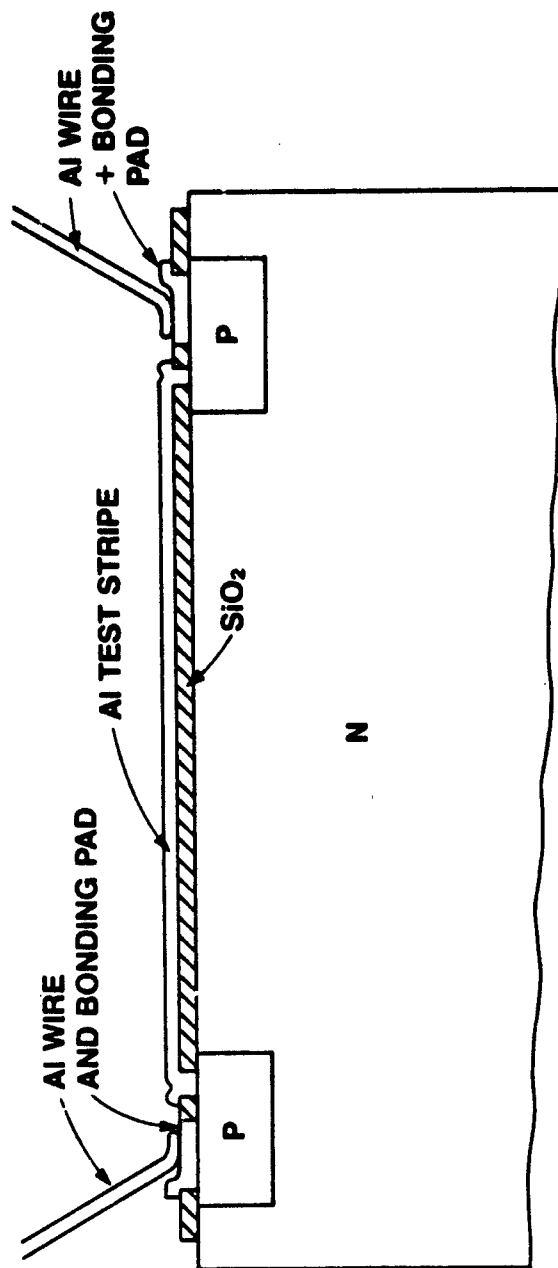
FIGURE 32. SCHEMATIC OF HIGH TEMPERATURE TEST STRUCTURE CROSS SECTION PRIOR TO PASSIVATION.

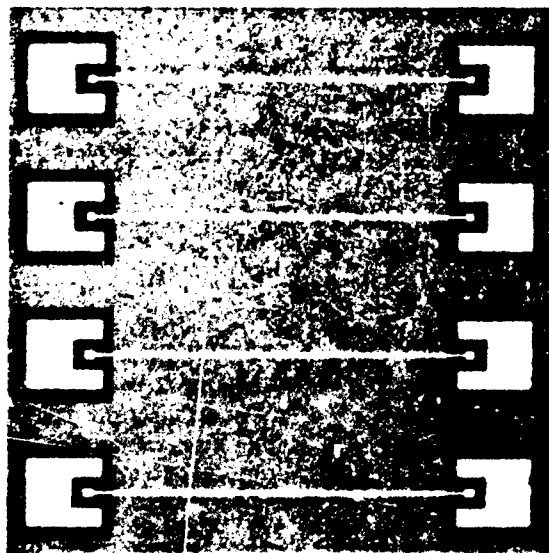
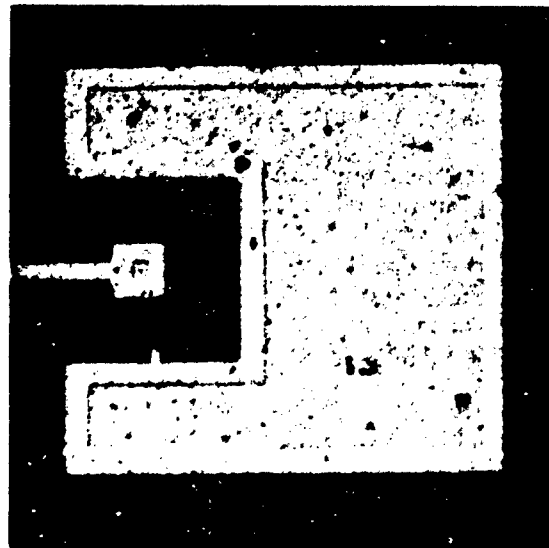
FIGURE 33. (a) 80 x 80 MIL HIGH TEMPERATURE TEST STRUCTURE (b) ENLARGED VIEW OF DIFFUSED REGION, OHMIC CONTACT AND WIRE BOND PAD.

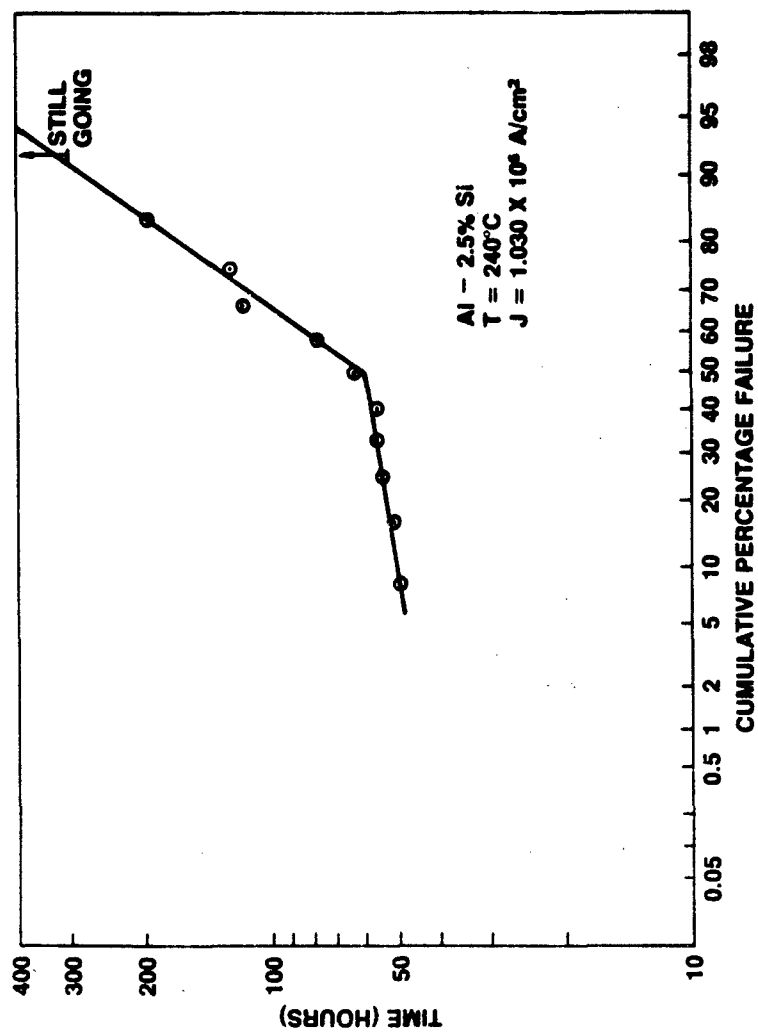
FIGURE 34. BIMODAL FAILURE DISTRIBUTION

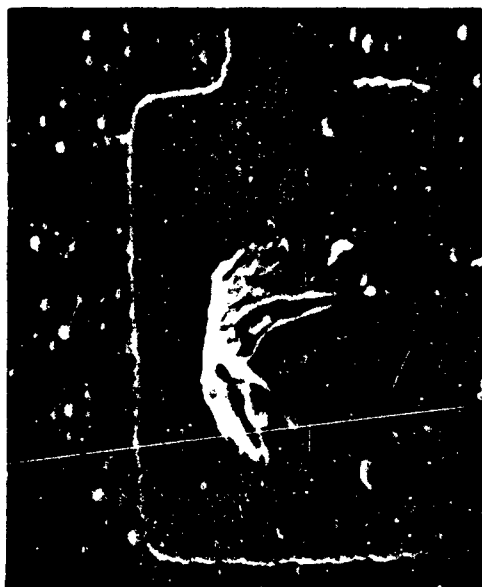
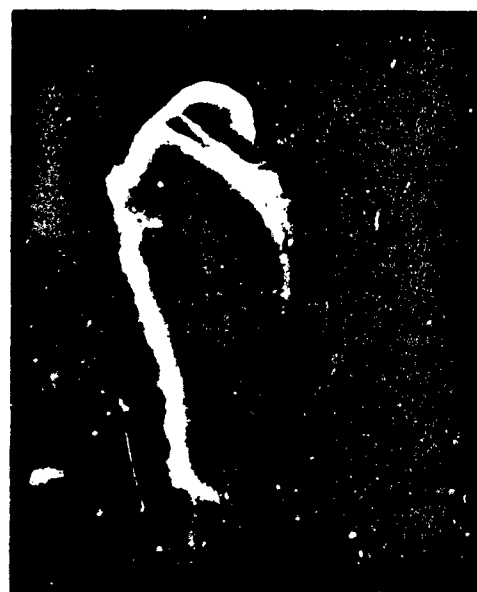
FIGURE 35. DEVICE STRESSED AT 310°C AND $J = 4.95 \times 10^5 \text{ A/cm}^2$ PRIOR TO PASSIVATION GLASS REMOVAL.

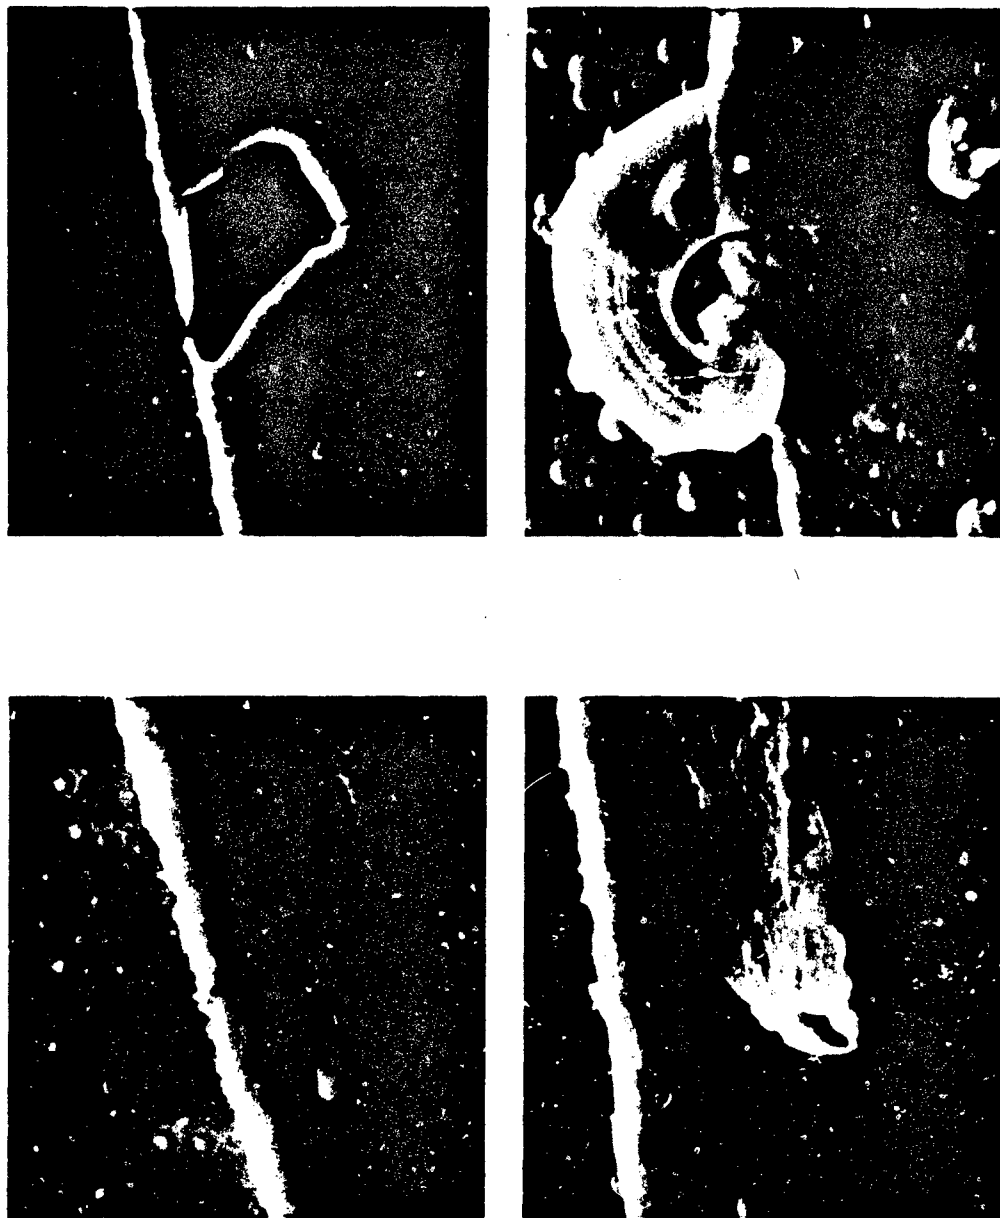
**FIGURE 41. TYPICAL VOIDS AND HILLOCKS OBSERVED IN HIGH TEMPERATURE
Al/Si FILMS DUE TO ALUMINUM ELECTROMIGRATION IN Al.**

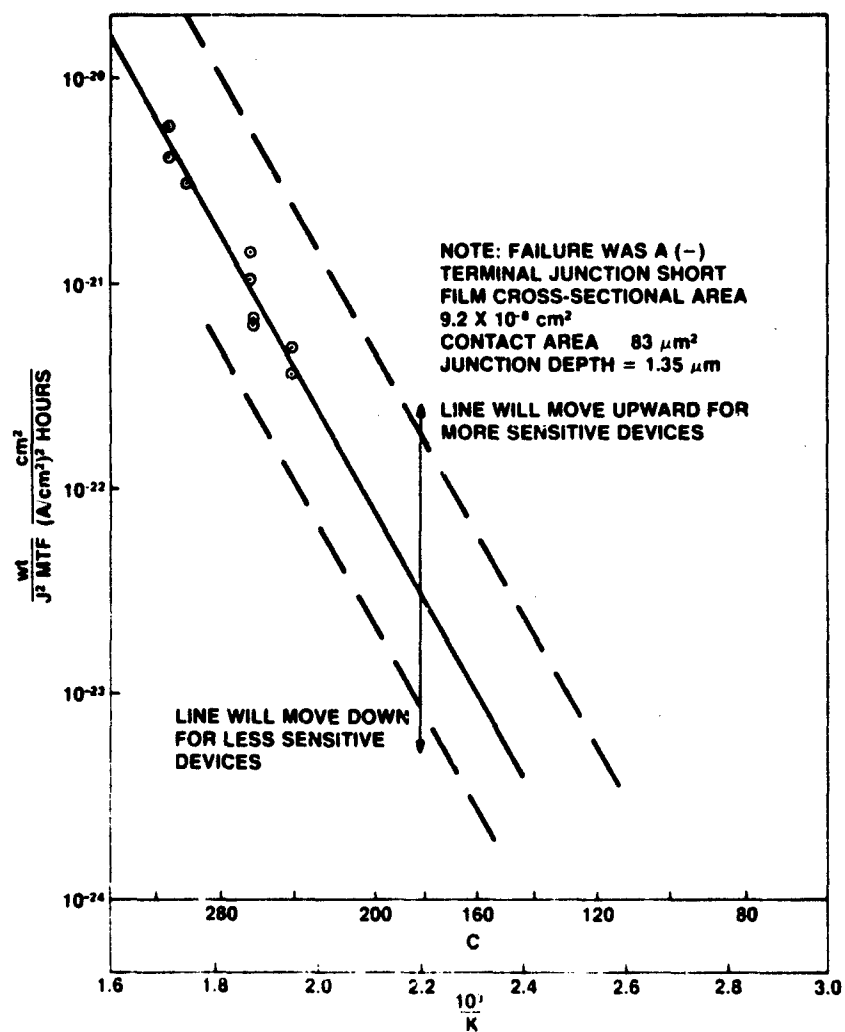
FIGURE 42. Al/Si ALLOY MEDIAN TIME TO FAILURE DUE TO THE ELECTROMIGRATION OF Si IN Al RELATED TO FILM GEOMETRY, CURRENT DENSITY AND TEMPERATURE
